CASE STUDY

Service: Concrete Repairs

Project: Thames Water

Location: Borden, Hampshire

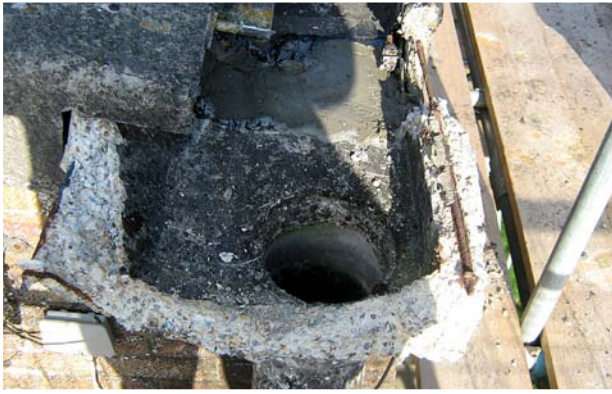
Installation overview

The workshop building at the water treatment works had precast concrete sectional guttering with rain water outlets at each end of the building. Each end outlet section had degraded badly with most of the reinforcement visible. The sections were no longer available so rebuilding of the section was the only remedial option as the cost to replace the gutter was outside the maintenance budgets.

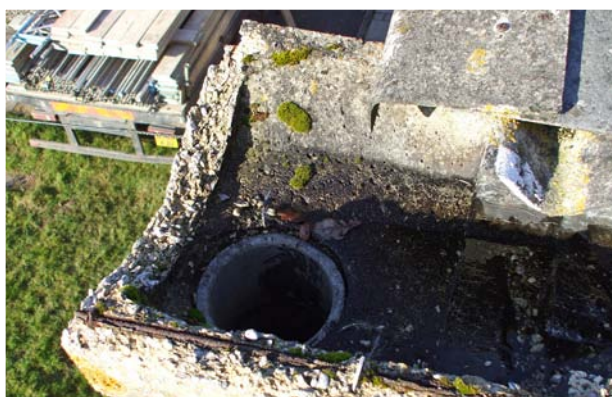
Due to the age and frailty of the gutter only insitu repairs could be considered. Traditional cementitious repair mortars were ruled out due to the product weight and requirement of shuttering to support the mortar whilst curing.

A lightweight repair mortar was required that required no shuttering and with selected primers adhered firmly to the existing concrete and coated the reinforcing bars to prevent further oxidation.
