CASE STUDY

Service: Gutter Lining
Project: Thames Water
Location: Whitney WTW

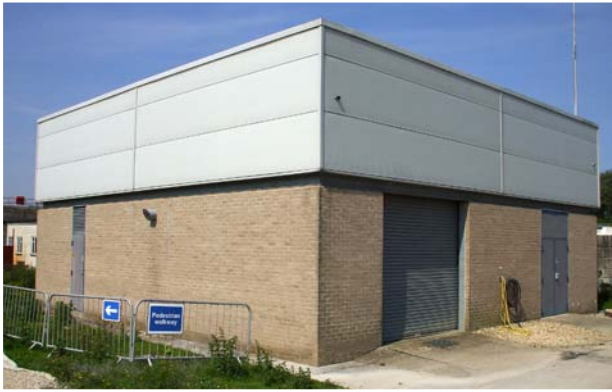
Installation overview

The galvanised sectional steel gutters servicing this building had lost its protection and was degrading badly. 50% of the gutter joints and all 4 outlets were leaking.

Pin holing to the steel was evident in places; replacement was difficult and costly due to access around the fixed machinery located within the building.
